## HLH ROTOR BLADE MANUFACTURING TECHNOLOGY DEVELOPMENT REPORT

Boeing Vertol Company  
P. O. Box 16858  
Philadelphia, Penn. 19142

September 1977

Final Report

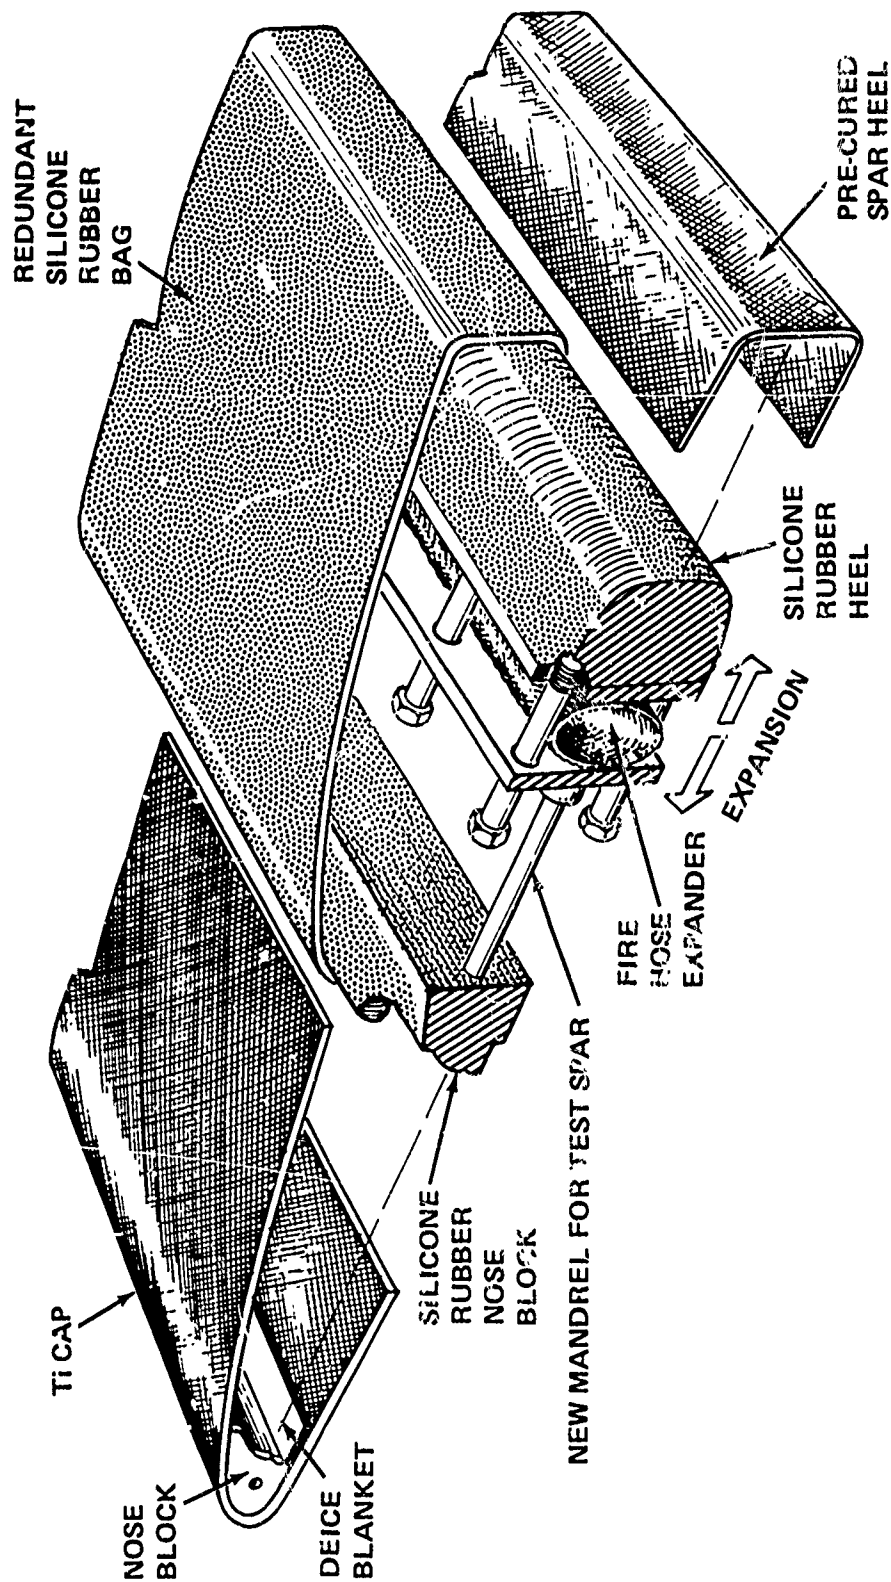
Figure 145. Simultaneous Cure of Nose Block and Spar Heel Results in Reduced Fabrication and Assembly Manhours

4. Bond AF30 adhesive into the titanium cap
5. Provide for bonding tool tabs to the outside of the titanium cap
6. Cure the spar heel.

The decision was then made to produce a second test specimen of the tip section (Stations 469 to 552) using a new mandrel configuration (Figure 145) which would:

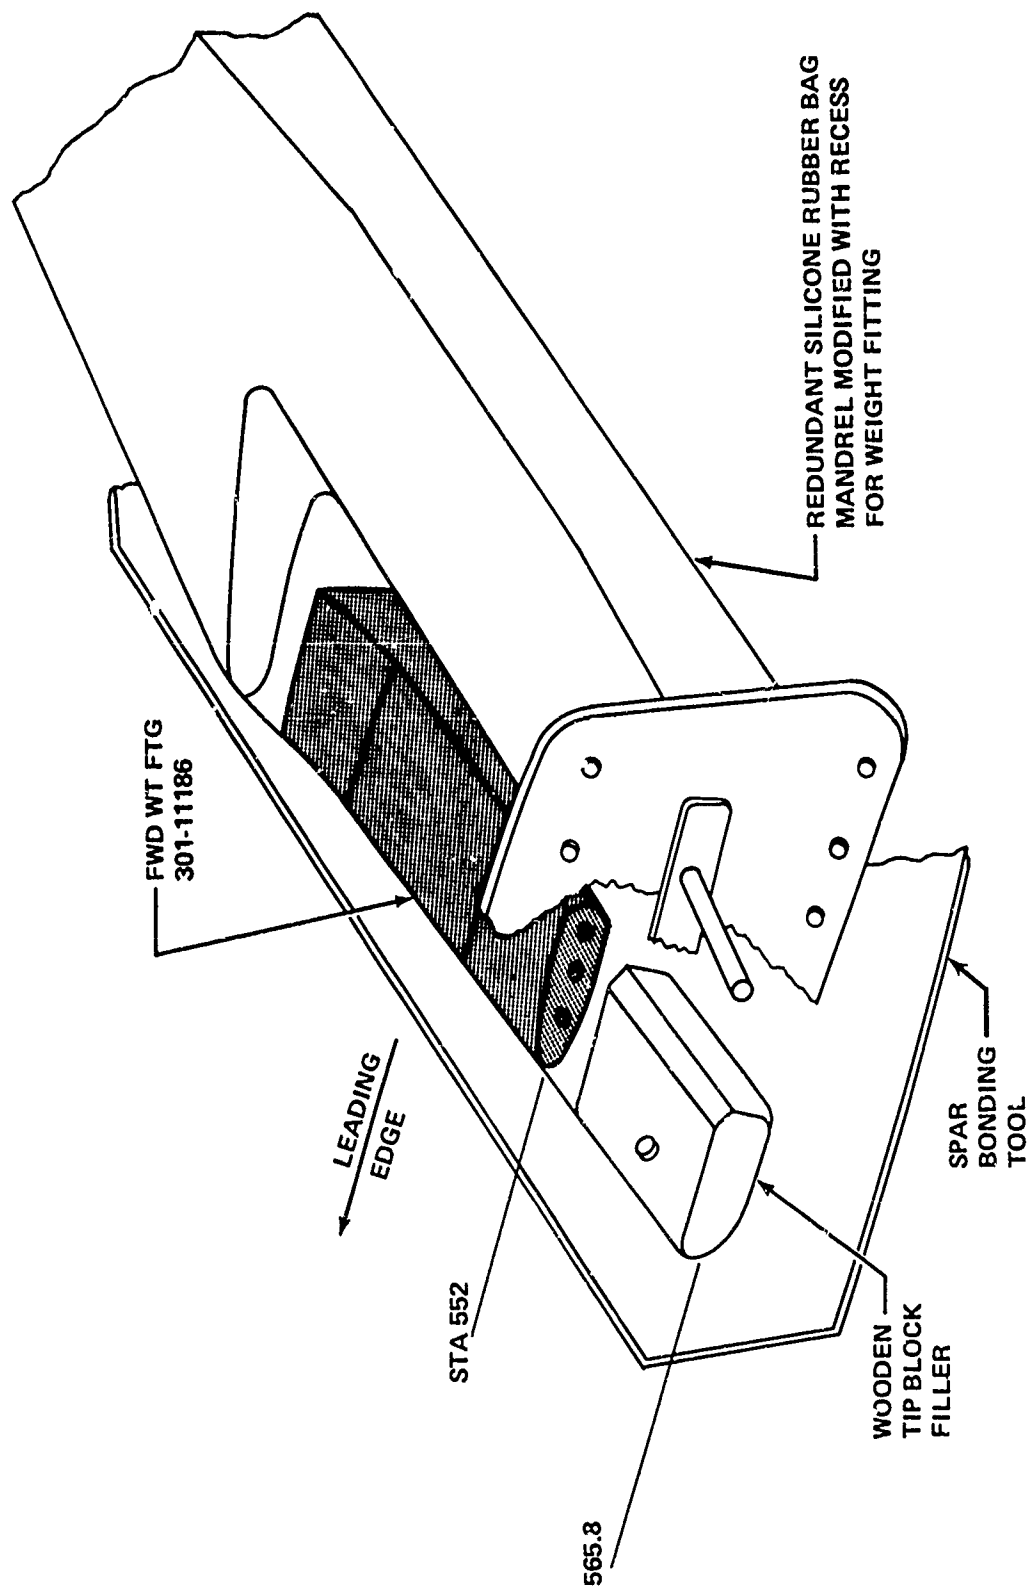
Figure 146. Improved Forward Weight Fitting Mandrel

To improve the weight fitting bond line and reduce cost, a test part has been produced with a modified mandrel (Figure 146) which permits installation of the weight fitting on the spar mandrel during lay-up of the spar. The weight fitting was then bonded or co-cured to the spar at the same time the spar was cured. This technique proved successful and will be incorporated on the prototype blades.

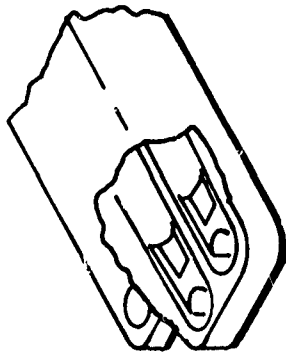
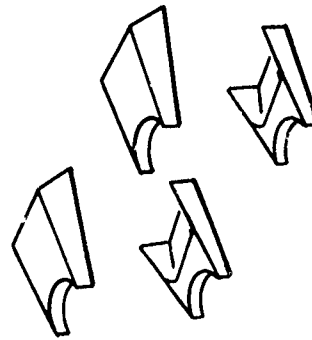
*Figure 147. Droop Stop Fittings*

#### PROTOTYPE CONFIGURATION

- . Droop fittings cured in place during spar cure.
- . No separate fabrication required.
- . Design to cost savings.

#### ATC CONFIGURATION

- . Four (4) fittings hot bonded to root end.
- . Fittings are all different due to internal blade contour - high cost for hand fitting.
- . Hot bonding of fittings was unsuccessful and development was deemed to be not cost effective.
- . Therefore fittings were cold bonded for ATC Program.
- . Strength of cold bond questionable at temperature extremes and would require increased fitting size for Prototype.
- . Bonds hard to inspect and unrepairable.

The four 301-11204 Droop Stop Fittings (Figure 147), located in the root end of the spar, were also very difficult to hand-fit prior to bonding. A similar approach to that described for the forward weight fittings is under evaluation to improve this installation.
